# Access Compliance Report Public Rights-of-Way (Curb Ramps)

Main Street: PYLE WAY Cross Street: RIATA\_ST Location: SE

ADA ID: RPRK220203123246 Ramp Type: Type 4 - Parallel Initial Pass/Fail: Fail Overall Compliance: No Severity Score: 2

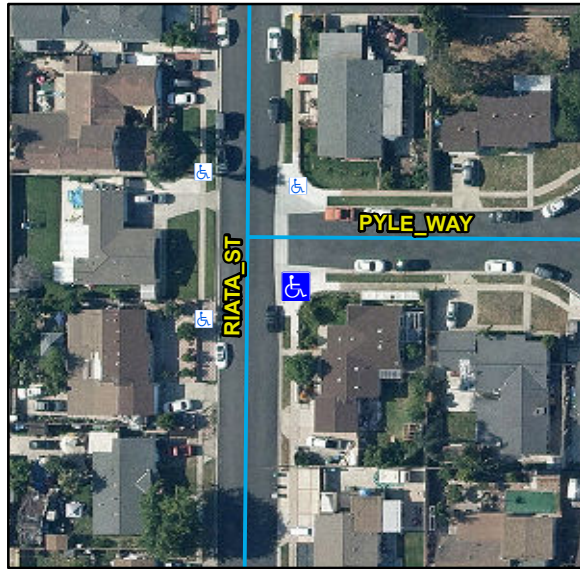
| Compliance | Description | Data | Compliance | Description | Data |
|---|---|---|---|---|---|
| No | Ramp Cross Slope LT (%) | 2.1 | No | Ramp Cross Slope RT (%) | 3.2 |

**Remove & Replace Curb Ramp With Two New Directional Ramps or Equivalent.**

**R304.5.3, STD 1115**
