# Access Compliance Report Public Rights-of-Way (Curb Ramps)

Main Street: RIATA\_ST Cross Street: BIRD\_RD Location: NE

ADA ID: RPRK220203123515 Ramp Type: Type 4 - Parallel Initial Pass/Fail: Fail Overall Compliance: No Severity Score: 2

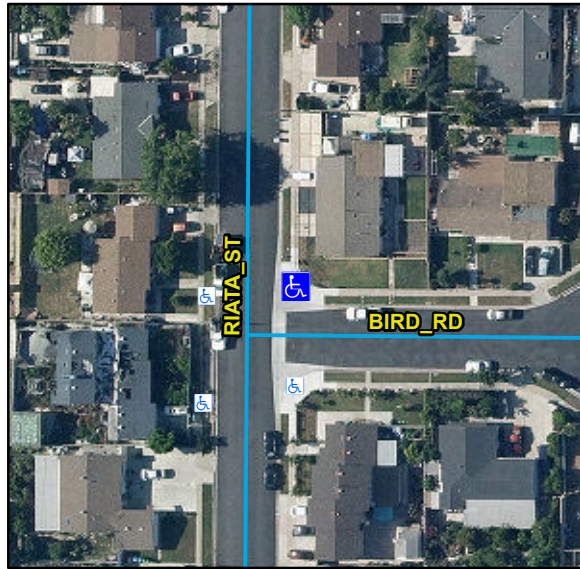
| Compliance | Description | Data | Compliance | Description | Data |
|---|---|---|---|---|---|
| No | Ramp Cross Slope LT (%) | 2.8 | No | Ramp Cross Slope RT (%) | 3.5 |

**Remove & Replace Curb Ramp With Two New Directional Ramps or Equivalent.**

**R304.5.3, STD 1115**
