# Access Compliance Report Public Rights-of-Way (Curb Ramps)

Main Street: BIRD\_RD Cross Street: RIATA\_ST Location: SE

ADA ID: RPRK220203123856 Ramp Type: Type 4 - Parallel Initial Pass/Fail: Fail Overall Compliance: No Severity Score: 2

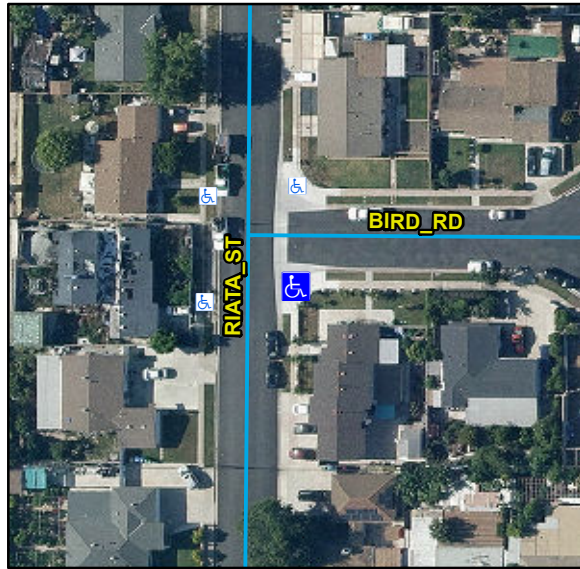
| Compliance | Description | Data | Compliance | Description | Data |
|---|---|---|---|---|---|
| No | Ramp Cross Slope LT (%) | 2.7 | No | Ramp Cross Slope RT (%) | 3.6 |

**Remove & Replace Curb Ramp With Two New Directional Ramps or Equivalent.**

**R304.5.3, STD 1115**
