# Access Compliance Report Public Rights-of-Way (Curb Ramps)

| Main Street: RIATA_ST | | Cross Street: MADISON_AVE | | Location: | NE |
| ADA ID: RPRK220203125915 | Ramp Type: Type 4 - Parallel | Initial Pass/Fail: Fail | Overall Compliance: No | Severity Score: | 15 |

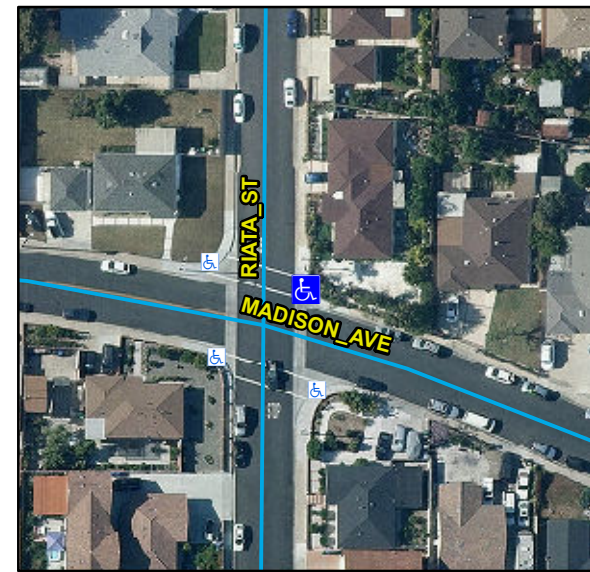
| Compliance | Description | Data | Compliance | Description | Data |
|---|---|---|---|---|---|
| No | Ramp Run Slope LT (%) | 9 | Yes | Ramp Run Slope RT (%) | 7.6 |

**Remove & Replace Curb Ramp With Two New Directional Ramps or Equivalent.**

**R304.3.2, STD 1115**

Total Cost: \$ 4000

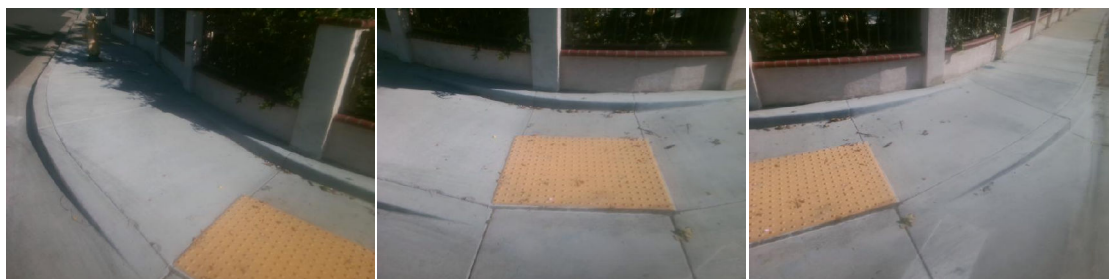
| Compliance | Description | Data | Compliance | Description | Data |
|---|---|---|---|---|---|
| N/A | Ramp Length LT (in) | 79 | N/A | Ramp Length RT (in) | 80 |
| Yes | Ramp Width LT (in) | 61 | Yes | Ramp Width RT (in) | 61 |
| Yes | Ramp Cross Slope LT (%) | 0 | Yes | Ramp Cross Slope RT (%) | 1.3 |
