# Access Compliance Report Public Rights-of-Way (Curb Ramps)

Main Street: NEWLAND\_ST Cross Street: MADISON\_AVE Location: NE

ADA ID: RPRK220203130432 Ramp Type: Type 4 - Parallel Initial Pass/Fail: Fail Overall Compliance: No Severity Score: 15

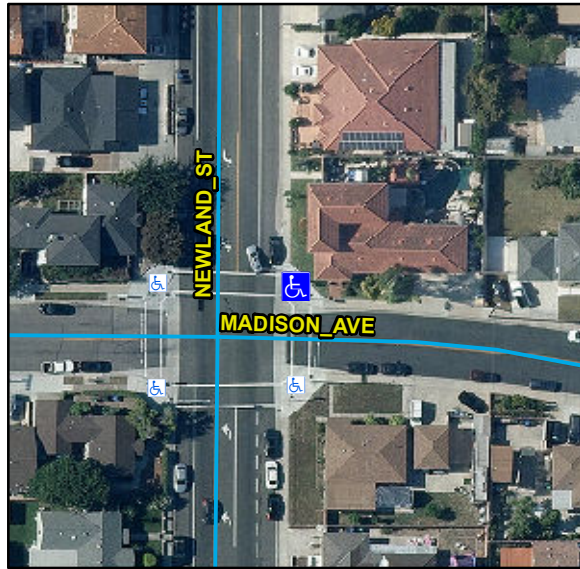
| Compliance | Description | Data | Compliance | Description | Data |
|---|---|---|---|---|---|
| No | Ramp Cross Slope LT (%) | 5.5 | No | Ramp Cross Slope RT (%) | 6.1 |

**Remove & Replace Curb Ramp With Two New Directional Ramps or Equivalent.**

**R304.5.3, STD 1115**

Total Cost: \$ 4000
