# Access Compliance Report Public Rights-of-Way (Curb Ramps)

Main Street: NEWLAND\_ST Cross Street: MADISON\_AVE Location: SW

ADA ID: RPRK220203131054 Ramp Type: Type 4 - Parallel Initial Pass/Fail: Fail Overall Compliance: No Severity Score: 2

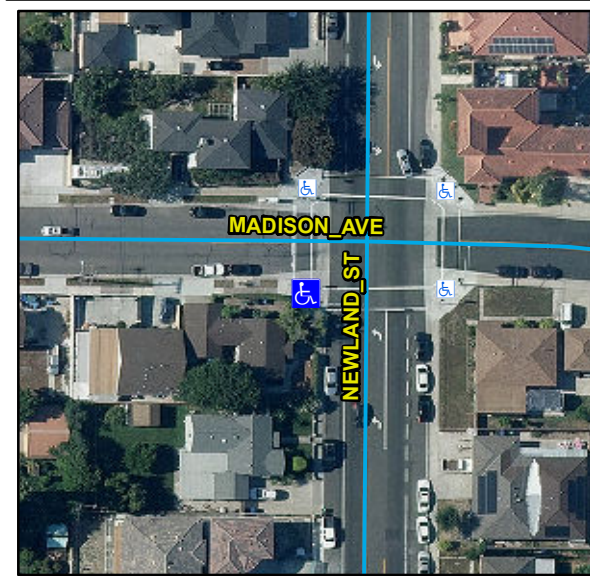
| Compliance | Description | Data | Compliance | Description | Data |
|---|---|---|---|---|---|
| No | Ramp Cross Slope LT (%) | 4.4 | No | Ramp Cross Slope RT (%) | 3.9 |

Possible Solutions:  
**Remove & Replace Curb Ramp With Two New Directional Ramps or Equivalent.**

OC Std/PROW:  
**R304.5.3, STD 1115**

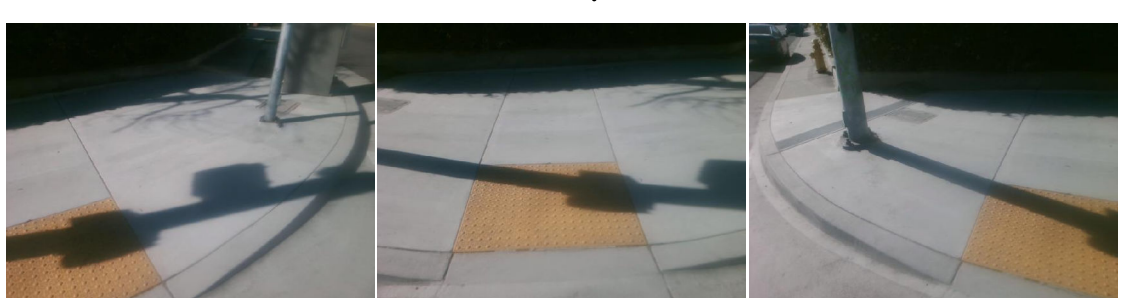
| Compliance | Description | Data | Compliance | Description | Data |
|---|---|---|---|---|---|
| Yes | Overall Surface Condition | Acceptable | | | |
| | Cross Gutter Present? | Yes | | Spandrel Present? | Yes |
