# Access Compliance Report Public Rights-of-Way (Curb Ramps)

Main Street: MADISON\_AVE Cross Street: NEWLAND\_ST Location: SE

ADA ID: RPRK220203131350 Ramp Type: Type 4 - Parallel Initial Pass/Fail: Fail Overall Compliance: No Severity Score: 15

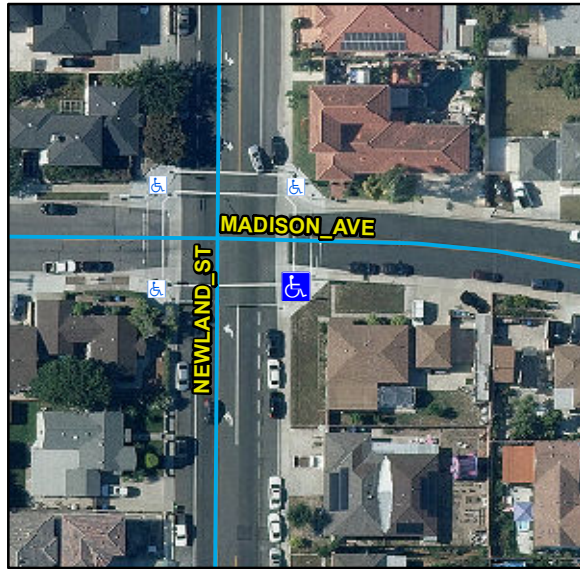
| Compliance | Description | Data | Compliance | Description | Data |
|---|---|---|---|---|---|
| No | Ramp Cross Slope LT (%) | 5 | No | Ramp Cross Slope RT (%) | 6.2 |

**Remove & Replace Curb Ramp With Two New Directional Ramps or Equivalent.**

**R304.5.3, STD 1115**
