# Access Compliance Report Public Rights-of-Way (Curb Ramps)

| Main Street: WASHINGTON_AVE | | Cross Street: RIATA_ST | | Location: | NW |
| ADA ID: RPRK220203133558 | Ramp Type: Type 4 - Parallel | Initial Pass/Fail: Pass | Overall Compliance: No | Severity Score: | 0 |

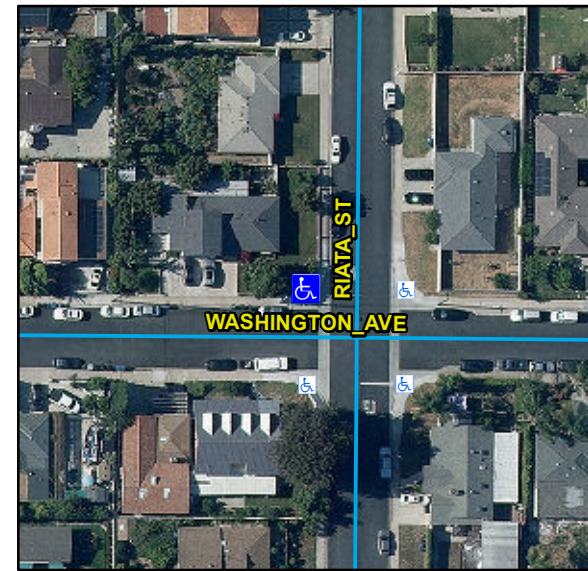
| Compliance | Description | Data | Compliance | Description | Data |
|---|---|---|---|---|---|
| No | Landing Run Slope (%) | 2.1 | Yes | DWS Full Width | Yes |

Possible Solutions:

Remove & Replace Landing.

R304.2.2-Perp, R304.3.2-Para, STD 1115
