# Access Compliance Report Public Rights-of-Way (Curb Ramps)

Main Street: WASHINGTON\_AVE Cross Street: RIATA\_ST Location: SE

ADA ID: RPRK220203134250 Ramp Type: Type 4 - Parallel Initial Pass/Fail: Fail Overall Compliance: No Severity Score: 16

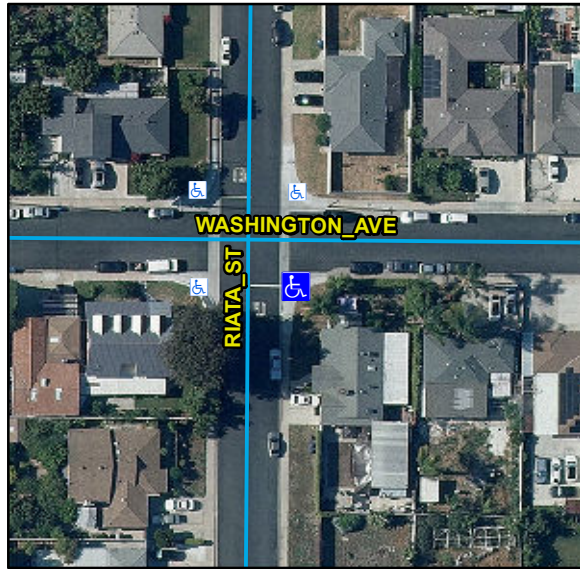
| Compliance | Description | Data | Compliance | Description | Data |
|---|---|---|---|---|---|
| No | Ramp Run Slope LT (%) | 8.9 | Yes | Ramp Run Slope RT (%) | 7.3 |

**Remove & Replace Curb Ramp With Two New Directional Ramps or Equivalent.**

**R304.3.2, STD 1115**
