# Access Compliance Report Public Rights-of-Way (Curb Ramps)

Main Street: BOLSA\_AVE\_FRONTAGE\_ROAD Cross Street: RIATA\_ST Location: NW

ADA ID: RPRK220203135606 Ramp Type: Type 4 - Parallel Initial Pass/Fail: Pass Overall Compliance: No Severity Score: 0

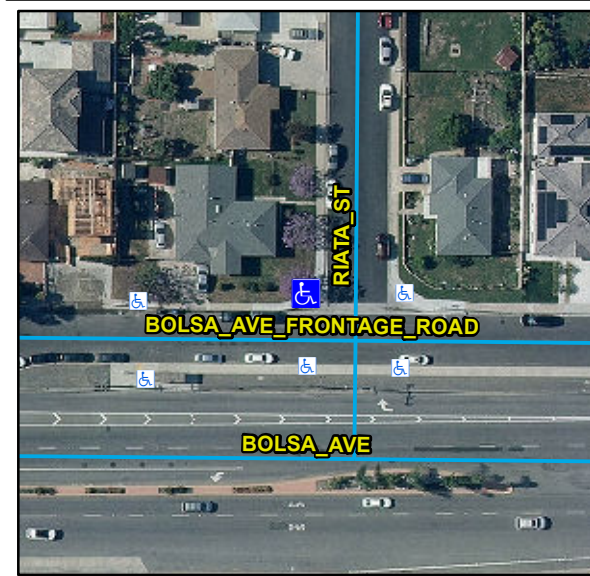
| Compliance | Description | Data | Compliance | Description | Data |
|---|---|---|---|---|---|
| No | Landing Run Slope (%) | 2.7 | Yes | DWS Full Width | Yes |

Possible Solutions:  
**Remove & Replace Landing.**
