# Access Compliance Report Public Rights-of-Way (Curb Ramps)

Main Street: HARPER\_ST Cross Street: SATINWOOD\_CIR Location: NE

ADA ID: RPRK220203141246 Ramp Type: Type 4 - Parallel Initial Pass/Fail: Fail Overall Compliance: No Severity Score: 15

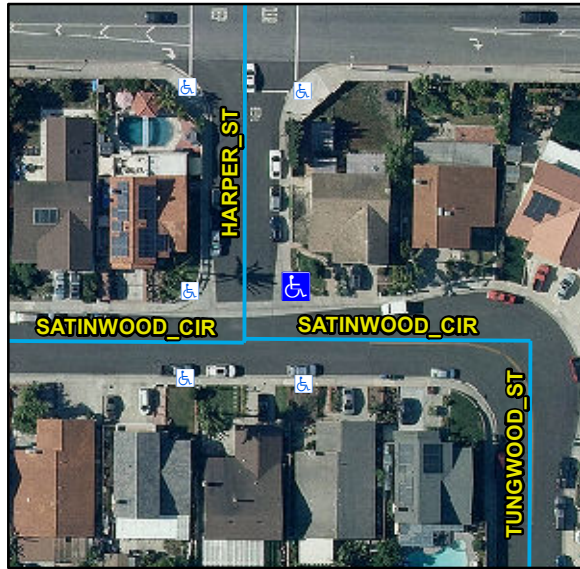
| Compliance | Description | Data | Compliance | Description | Data |
|---|---|---|---|---|---|
| No | Ramp Cross Slope LT (%) | 5.9 | No | Ramp Cross Slope RT (%) | 5.4 |

**Remove & Replace Curb Ramp With Two New Directional Ramps or Equivalent.**

**R204.3, R304.5.3, STD 1115**
