# Access Compliance Report Public Rights-of-Way (Curb Ramps)

Main Street: SATINWOOD\_CIR Cross Street: HARPER\_ST Location: NW

ADA ID: RPRK220203141611 Ramp Type: Type 4 - Parallel Initial Pass/Fail: Fail Overall Compliance: No Severity Score: 15

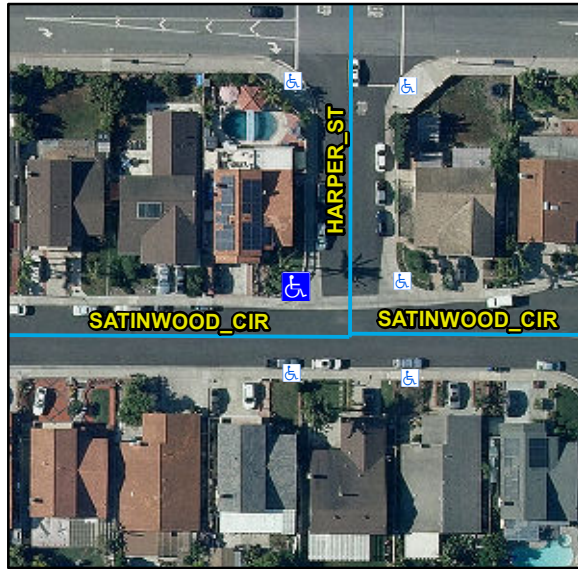
| Compliance | Description | Data | Compliance | Description | Data |
|---|---|---|---|---|---|
| No | Ramp Cross Slope LT (%) | 6.3 | No | Ramp Cross Slope RT (%) | 6.4 |
| N/A | Gutter Cross Slope (%) | N/A | No | Perpendicular Joint Present | No |

**Remove & Replace Curb Ramp With Two New Directional Ramps or Equivalent.**

**R204.3, R304.5.3, STD 1115**
