# Access Compliance Report Public Rights-of-Way (Curb Ramps)

Main Street: BOLSA\_AVE Cross Street: NEWLAND\_ST Location: SE

ADA ID: RPRK220203142208 Ramp Type: Type 4 - Parallel Initial Pass/Fail: Fail Overall Compliance: No Severity Score: 16

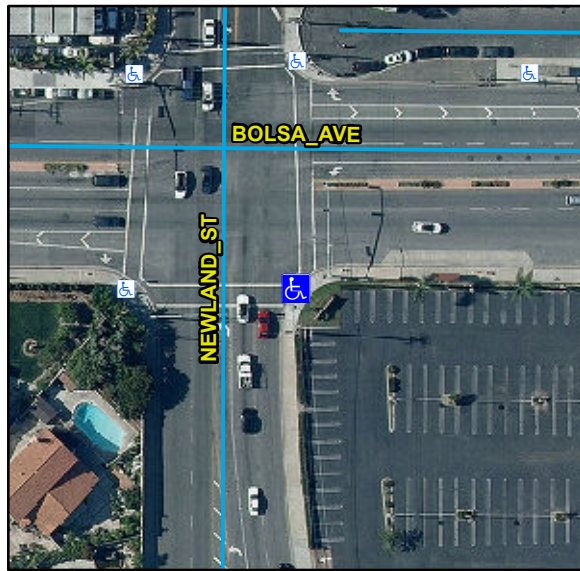
| Compliance | Description | Data | Compliance | Description | Data |
|---|---|---|---|---|---|
| No | Ramp Run Slope LT (%) | 9.4 | Yes | Ramp Run Slope RT (%) | 6.9 |
| No | Ramp Cross Slope LT (%) | 4.8 | No | Ramp Cross Slope RT (%) | 4.5 |

**Remove & Replace Curb Ramp With Two New Directional Ramps or Equivalent.**

**R304.3.2, R304.5.3, STD 1115**
