# Access Compliance Report Public Rights-of-Way (Curb Ramps)

Main Street: NEWLAND\_ST Cross Street: WHITLEY\_AVE Location: NE

ADA ID: RPRK220203142452 Ramp Type: Type 1 - Perpendicular Diagonal Initial Pass/Fail: Pass Overall Compliance: No Severity Score: 24

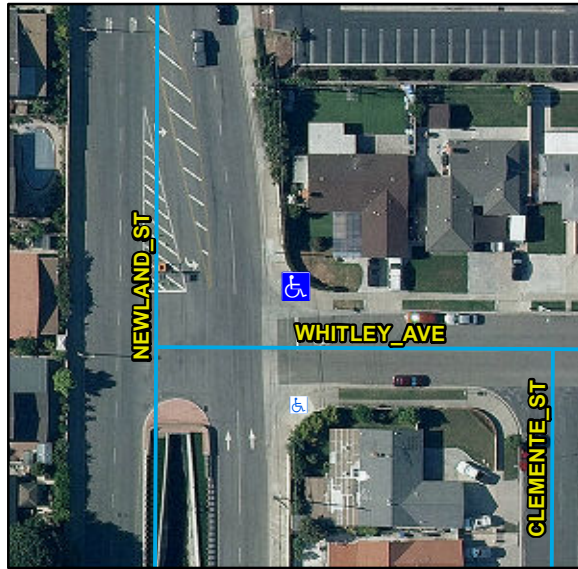
| Compliance | Description | Data | Compliance | Description | Data |
|---|---|---|---|---|---|
| No | Landing Cross Slope (%) | N/A | No | DWS Provided | No |
| No | Gutter Lip Height (in) | 0.5 | | Road Run Slope (%) | 0.9 |
| No | Gutter Cross Slope (%) | 3.4 | | | |

Remove & Replace Curb Ramp With Two New Directional Ramps or Equivalent. Remove & Replace Gutter.
