# Access Compliance Report Public Rights-of-Way (Curb Ramps)

Main Street: WHITLEY\_AVE Cross Street: NEWLAND\_ST Location: SE

ADA ID: RPRK220203142837 Ramp Type: Type 1 - Perpendicular Diagonal Initial Pass/Fail: Fail Overall Compliance: No Severity Score: 2

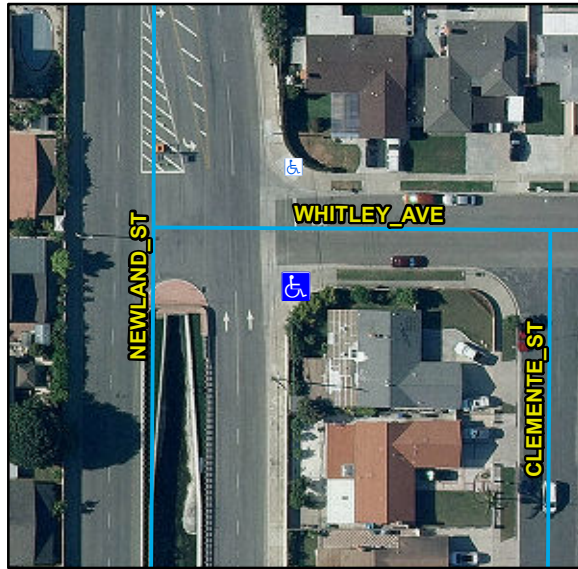
| Compliance | Description | Data | Compliance | Description | Data |
|---|---|---|---|---|---|
| No | Ramp Cross Slope (%) | 2.4 | N/A | Flare Traversable LT | N/A |
| No | Gutter Lip Height (in) | 1 | | Road Run Slope (%) | 3.3 |

Remove & Replace Curb Ramp With Two New Directional Ramps or Equivalent. Grind Gutter Lip.
