# Access Compliance Report Public Rights-of-Way (Curb Ramps)

Main Street: PURDY\_ST Cross Street: BOLSA\_AVE\_FRONTAGE\_ROAD Location: NE

ADA ID: RPRK220203144841 Ramp Type: Type 4 - Parallel Initial Pass/Fail: Fail Overall Compliance: No Severity Score: 15

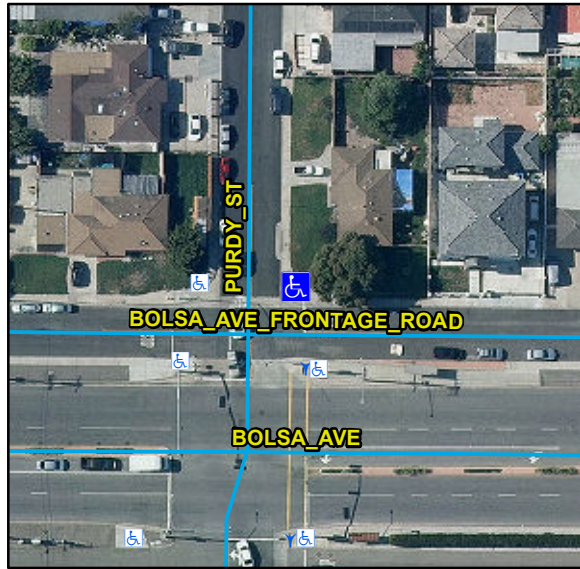
| Compliance | Description | Data | Compliance | Description | Data |
|---|---|---|---|---|---|
| Yes | Ramp Run Slope LT (%) | 5.8 | No | Ramp Run Slope RT (%) | 8.6 |

**Remove & Replace Curb Ramp With Two New Directional Ramps or Equivalent.**

R304.3.2, STD 1115

\$ 4000
