# Access Compliance Report Public Rights-of-Way (Curb Ramps)

Main Street: PURDY\_ST Cross Street: MADISON\_AVE Location: SW

ADA ID: RPRK220203151102 Ramp Type: Type 4 - Parallel Initial Pass/Fail: Fail Overall Compliance: No Severity Score: 4

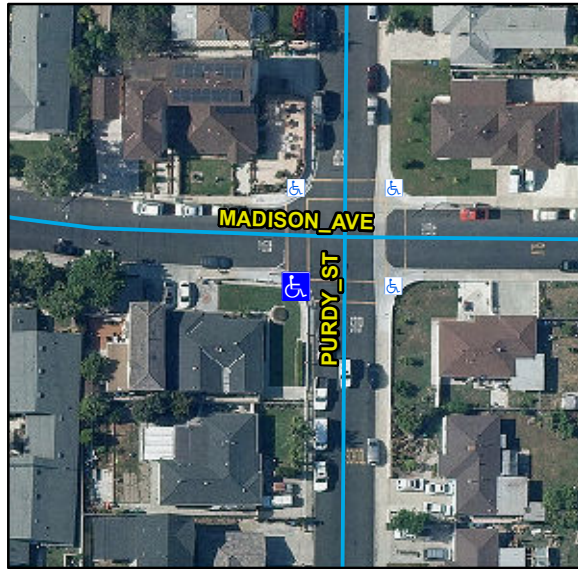
| Compliance | Description | Data | Compliance | Description | Data |
|---|---|---|---|---|---|
| No | Ramp Width LT (in) | 47 | No | Ramp Width RT (in) | 47 |

**Remove & Replace Curb Ramp With Two New Directional Ramps or Equivalent.**

**R304.5.1, STD 1115**
