# Access Compliance Report Public Rights-of-Way (Curb Ramps)

Main Street: HUNTER\_LN Cross Street: MADISON\_AVE Location: SW

ADA ID: RPRK220203151851 Ramp Type: Type 4 - Parallel Initial Pass/Fail: Pass Overall Compliance: No Severity Score: 5

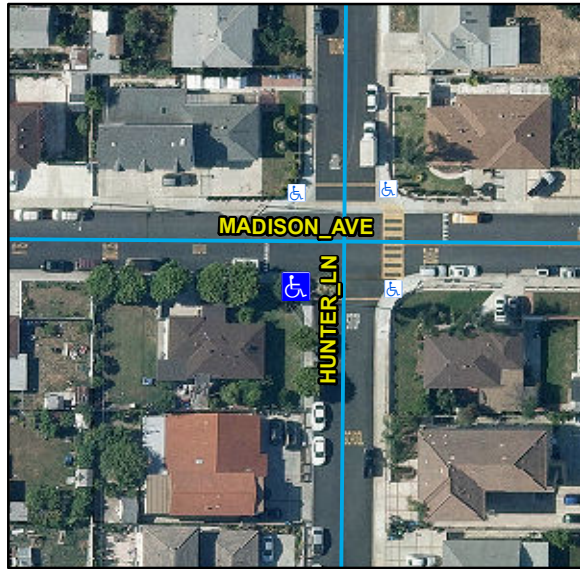
| Compliance | Description | Data | Compliance | Description | Data |
|---|---|---|---|---|---|
| No | Gutter Run Slope (%) | 5.7 | | Road Cross Slope (%) | 3.9 |

Remove & Replace Gutter.

R304.5.4, STD 1115

Total Cost: \$ 252
