# Access Compliance Report Public Rights-of-Way (Curb Ramps)

Main Street: HUNTER\_LN Cross Street: MADISON\_AVE Location: NE

ADA ID: RPRK220203152543 Ramp Type: Type 4 - Parallel Initial Pass/Fail: Pass Overall Compliance: No Severity Score: 0

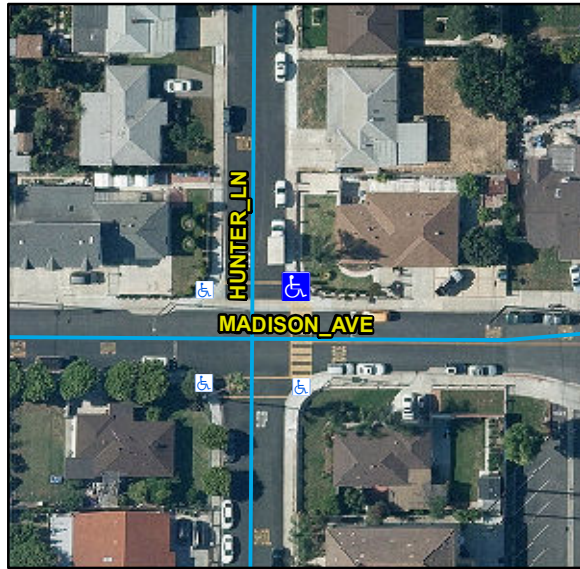
| Compliance | Description | Data | Compliance | Description | Data |
|---|---|---|---|---|---|
| No | Gutter Cross Slope (%) | 2.2 | Yes | Perpendicular Joint Present | Yes |

Remove & Replace Gutter.

R304.5.3, STD 1115
