# Access Compliance Report Public Rights-of-Way (Curb Ramps)

| Main Street: ROOSEVELT_AVE | | Cross Street: HUNTER_LN | | Location: | SE |
| ADA ID: RPRK220203154908 | Ramp Type: Type 4 - Parallel | Initial Pass/Fail: Pass | Overall Compliance: No | Severity Score: | 5 |

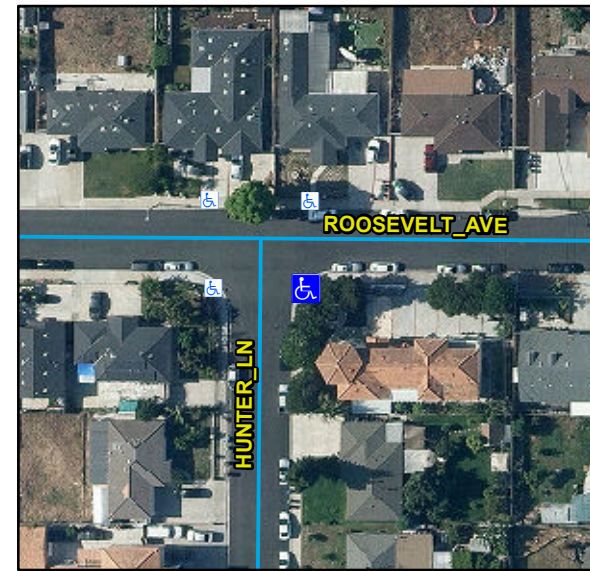
| Compliance | Description | Data | Compliance | Description | Data |
|---|---|---|---|---|---|
| No | Gutter Run Slope (%) | 5.5 | | Road Cross Slope (%) | 3.8 |

Possible Solutions:

Remove & Replace Gutter.

R304.5.4, STD 1115

Total Cost: \$ 252

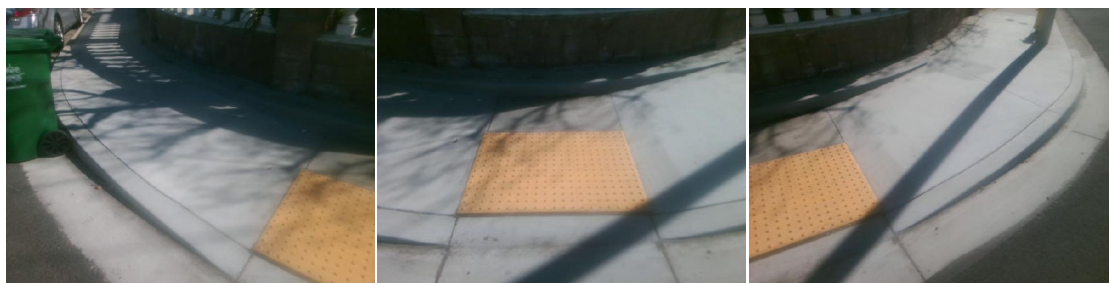
| Compliance | Description | Data | Compliance | Description | Data |
|---|---|---|---|---|---|
| N/A | Ramp Length LT (in) | 83 | N/A | Ramp Length RT (in) | 85 |
| Yes | Ramp Width LT (in) | 65 | Yes | Ramp Width RT (in) | 65 |
| Yes | Ramp Run Slope LT (%) | 7.1 | Yes | Ramp Run Slope RT (%) | 6.2 |
| Yes | Ramp Cross Slope LT (%) | 0.4 | Yes | Ramp Cross Slope RT (%) | 0.4 |
