# Access Compliance Report Public Rights-of-Way (Curb Ramps)

Main Street: WASHINGTON\_AVE Cross Street: BEACH\_BLVD Location: SE

ADA ID: RPRK220203162013 Ramp Type: Type 1 - Perpendicular Diagonal Initial Pass/Fail: Fail Overall Compliance: No Severity Score: 2

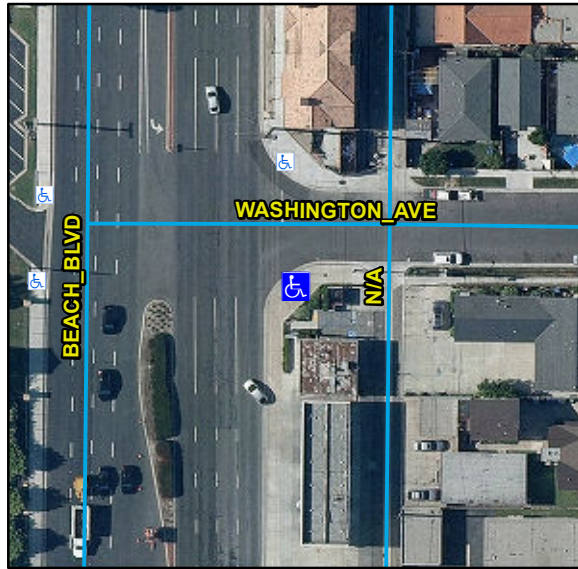
| Compliance | Description | Data | Compliance | Description | Data |
|---|---|---|---|---|---|
| No | Ramp Cross Slope (%) | 2.7 | N/A | Flare Traversable LT | N/A |
| No | Gutter Lip Height (in) | 0.5 | | Road Run Slope (%) | 1.6 |

Remove & Replace Curb Ramp With Two New Directional Ramps or Equivalent. Grind Gutter Lip.
