Main Street: BEACH\_BLVD Cross Street: WASHINGTON\_AVE Location: NE

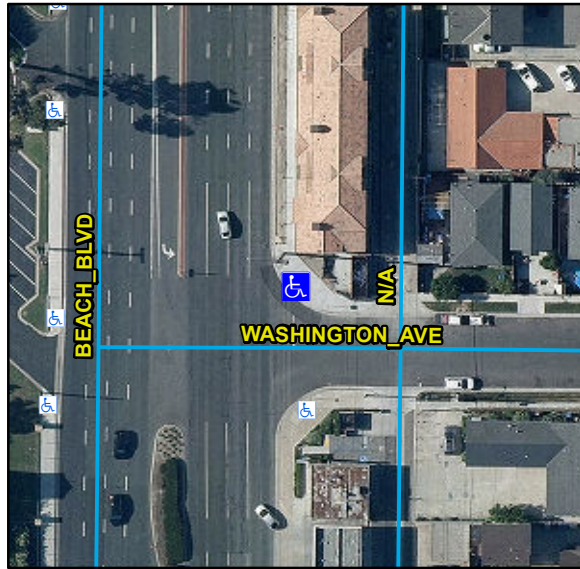
| Compliance | Description | Data | Compliance | Description | Data |
|---|---|---|---|---|---|
| No | Gutter Cross Slope (%) | 3.1 | | | |

Remove & Replace Gutter.

R304.5.3, STD 1115

Total Cost: \$ 252
