# Access Compliance Report Public Rights-of-Way (Curb Ramps)

Main Street: N/A Cross Street: BEACH\_BLVD Location: S

ADA ID: RPRK220203162649 Ramp Type: Type 7 - Directional 2 Initial Pass/Fail: Pass Overall Compliance: No Severity Score: 5

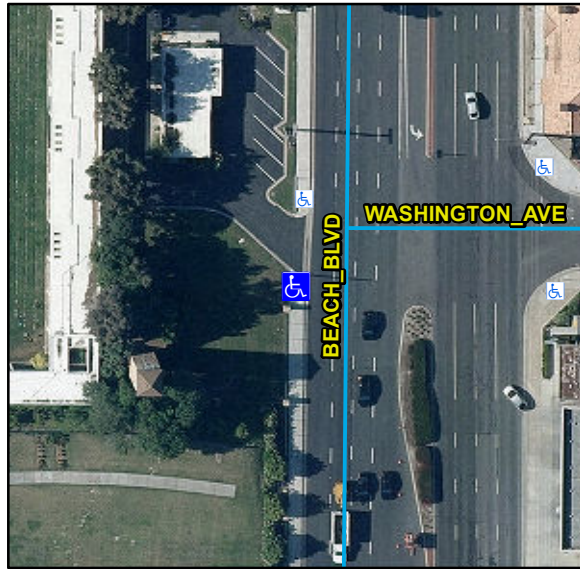
| Compliance | Description | Data | Compliance | Description | Data |
|---|---|---|---|---|---|
| Yes | Landing Cross Slope (%) | 1.7 | No | DWS Left Offset (in) | 12 |
| N/A | Landing Movement Obstructed? | No | No | DWS Right Offset (in) | 72 |
| No | Gutter Run Slope (%) | 7.3 | | Road Cross Slope (%) | N/A |

Possible Solutions:

Remove & Replace Detectable Warning System.  
Remove & Replace Gutter. Utility Present.

R305.2, R304.5.4, STD 1115

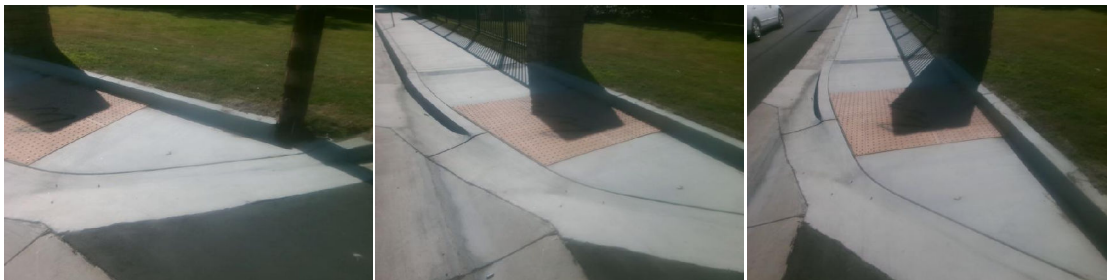
| Compliance | Description | Data | Compliance | Description | Data |
|---|---|---|---|---|---|
| Yes | Overall Surface Condition | Acceptable | Yes | Perp Joint Present | Yes |
| | Cross Gutter Present? | Yes | | Spandrel Present? | No |
| | Replace Cross Gutter? | No | | Replace Spandrel? | N/A |
