# Access Compliance Report Public Rights-of-Way (Curb Ramps)

Main Street: N/A Cross Street: BEACH\_BLVD Location: N

ADA ID: RPRK220203163737 Ramp Type: Type 7 - Directional 2 Initial Pass/Fail: Pass Overall Compliance: No Severity Score: 10

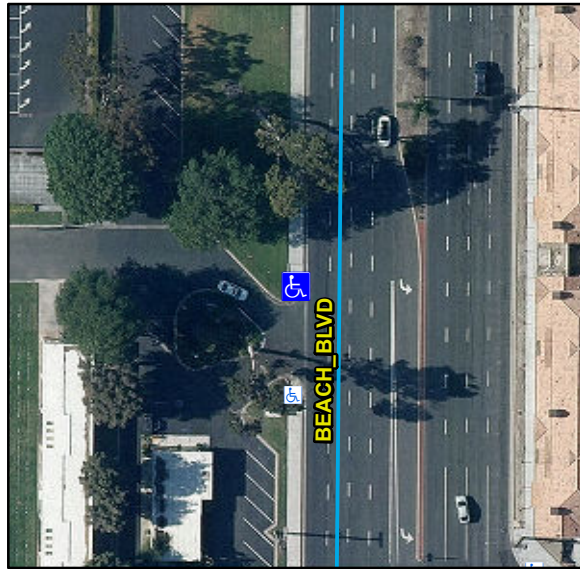
| Compliance | Description | Data | Compliance | Description | Data |
|---|---|---|---|---|---|
| No | Landing Length (in) | 40 | Yes | DWS Length (in) | 108 |
| Yes | Landing Cross Slope (%) | 1.2 | No | DWS Left Offset (in) | 39 |
| No | Gutter Ponding | Yes | Yes | Curb Slope | 2.1 |
| No | Gutter Run Slope (%) | 5.9 | | Road Cross Slope (%) | N/A |

**Remove & Replace Entire Ramp. Remove & Replace Gutter.**

**R304.2.1, R305.2, R302.7, R304.5.4, STD 1115**

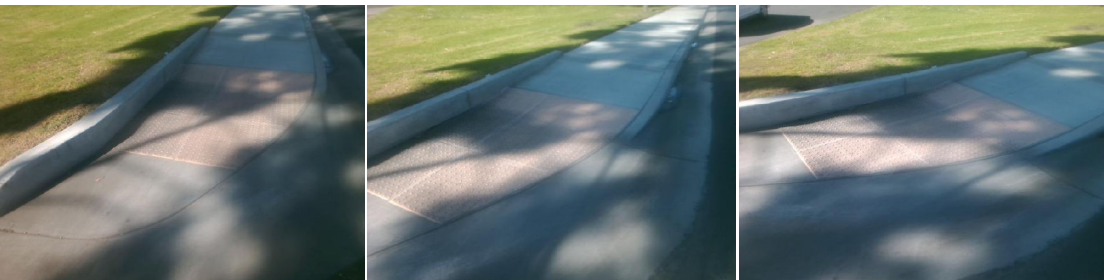
| Compliance | Description | Data | Compliance | Description | Data |
|---|---|---|---|---|---|
| Yes | Overall Surface Condition | Acceptable | Yes | Perp Joint Present | Yes |
| | Cross Gutter Present? | No | | Spandrel Present? | No |
| | Replace Cross Gutter? | N/A | | Replace Spandrel? | N/A |
