# Access Compliance Report Public Rights-of-Way (Curb Ramps)

Main Street: N/A Cross Street: BEACH\_BLV Location: N

ADA ID: RPRK220203164443 Ramp Type: Type 7 - Directional 2 Initial Pass/Fail: Fail Overall Compliance: No Severity Score: 15

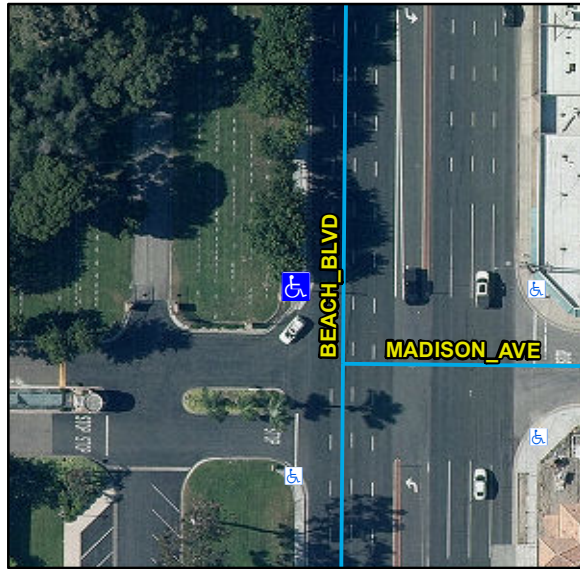
| Compliance | Description | Data | Compliance | Description | Data |
|---|---|---|---|---|---|
| No | Ramp Run Slope (%) | 9.9 | N/A | Flare Slope LT (%) | N/A |

Remove & Replace Entire Ramp.

R304.2.2, STD 1115
