# Access Compliance Report Public Rights-of-Way (Curb Ramps)

Main Street: VAN\_BUREN\_ST Cross Street: VAN\_BUREN\_ST Location: E

ADA ID: RPRK220207122420 Ramp Type: Type 1 - Perpendicular Initial Pass/Fail: Pass Overall Compliance: No Severity Score: 6

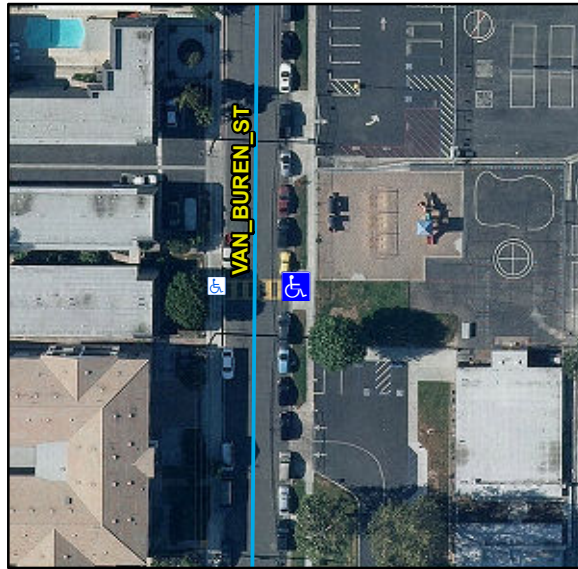
| Compliance | Description | Data | Compliance | Description | Data |
|---|---|---|---|---|---|
| N/A | Ramp Length (in) | 78 | No | Flare Type LT | |
| N/A | Landing Present | Yes | No | Flare Type RT | |
| No | Gutter Run Slope (%) | 7.4 | | Road Cross Slope (%) | N/A |

Remove & Replace Entire Ramp. Remove & Replace Gutter.

R304.2.1, R304.2.3, R304.5.4, STD 1115
