# Access Compliance Report Public Rights-of-Way (Curb Ramps)

| Main Street: VAN_BUREN_ST | | Cross Street: VAN_BUREN_ST | | Location: | W |
| ADA ID: RPRK220207122845 | Ramp Type: Type 4 - Parallel | Initial Pass/Fail: Fail | Overall Compliance: No | Severity Score: | 16 |

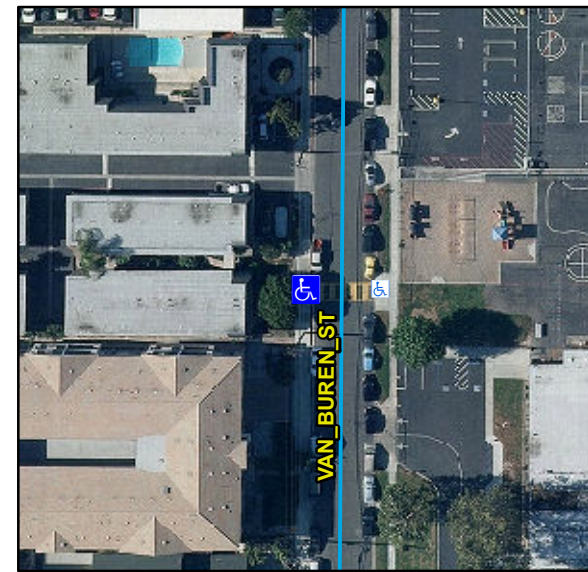
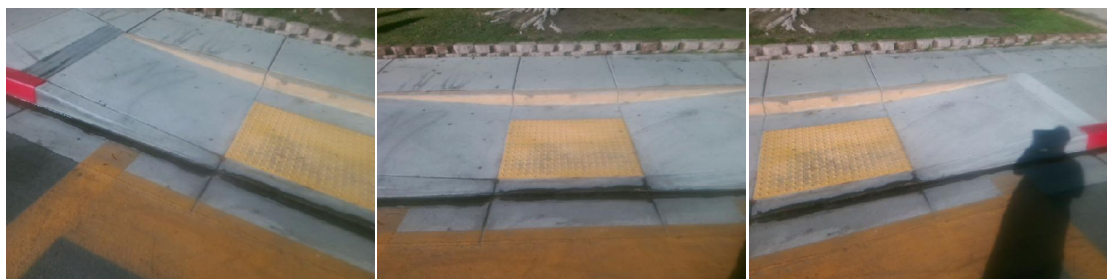
| Compliance | Description | Data | Compliance | Description | Data |
|---|---|---|---|---|---|
| No | Ramp Run Slope LT (%) | 9.2 | Yes | Ramp Run Slope RT (%) | 7.4 |
| No | Ramp Cross Slope LT (%) | 2.2 | No | Ramp Cross Slope RT (%) | 2.3 |

**Remove & Replace Entire Ramp.**

**R304.3.2, R304.5.3, STD 1115**

Total Cost: \$ 2000
