Access Compliance Report Public Rights-of-Way (Curb Ramps)

Main Street: CERRITOS_AVE	Cross Street: BROOKHURST_ST			Location:	SW
ADA ID: RPRK220207130920	Ramp Type: Type 4 - Parallel	Initial Pass/Fail: Pass	Overall Compliance: Yes	Severity Score:	0

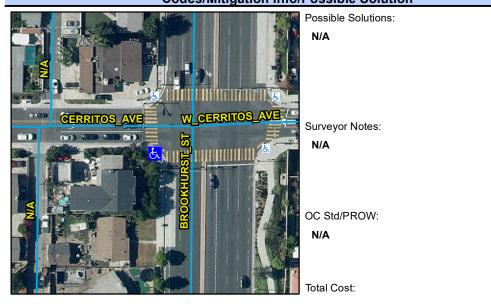
Field Measurements/Component Compliance							
	Compliance Description		Data	Compliance Description		Description	Data	
	N/A	Ramp Length LT (in)	80	N/A	Ramp Le	ength RT (in)	81	
	Yes	Ramp Width LT (in)	103	Yes	Ramp W	/idth RT (in)	103	
	Yes	Ramp Run Slope LT (%)	5.3	Yes	Ramp R	un Slope RT (%)	0.2	
	Yes	Ramp Cross Slope LT (%)	1.7	Yes	Ramp C	ross Slope RT (%)	0.7	
	N/A	Landing Present	Yes	Yes	DWS Pr	ovided	Yes	
	N/A	Landing Length (in)	103	Yes	DWS Co	ontrast	Yes	
	Yes	Landing Width (in)	48	Yes	DWS Le	ngth (in)	36	
	Yes	Landing Run Slope (%)	0.8	Yes	DWS Fu	ll Width	Yes	
	Yes	Landing Cross Slope (%)	0.6		DWS Of	fset Type	Single	
	N/A	Landing Movement Obstructed?	No	Yes	DWS Of	fset Left (in)	0	
		Landing Movement Type	Curb	Yes	DWS Of	fset Right (in)	N/A	
	N/A	Landing Shared	No					
	Yes	Clear Space	Yes					
	Yes	Clear Space To Crosswalk (in)	48					
0	N/A	Marked Crosswalk 1	Yes	N/A	Marked	Crosswalk 2	Yes	
		Crossing 1 Direction	E		Crossing	g 2 Direction	N

Έ		Marked Crosswalk 1 Width (in)	144		Marked	Crosswalk 2 Width (in)	144	
al	Yes	Ramp Inside Crosswalk 1	Yes	Yes	Ramp In	side Crosswalk 2	Yes	
Т		Crossing 1 Slope (%)	3.5		Crossing	g 2 Slope (%)	1.4	
al		Crossing 1 Cross Slope (%)	3.3		Crossing	g 2 Cross Slope (%)	0.6	
	Yes	Gutter Ponding	No	Yes	Curb Slo	ppe	6.1	
	Yes	Gutter Lip Height (in)	0		Road Ru	ın Slope (%)	0.2	
	Yes	Gutter Run Slope (%)	1.6		Road Cr	oss Slope (%)	3.7	
ta	Yes	Gutter Cross Slope (%)	1.1	Yes	Perpend	icular Joint Present	Yes	
lo	Yes	es Overall Surface Condition Acceptable						
ا ۱		Cross Gutter Present?	Yes		Spandre	el Present?	No	
Α		Replace Cross Gutter?	No		Replace	e Spandrel?	N/A	
1 1	1
