# Access Compliance Report Public Rights-of-Way (Curb Ramps)

Main Street: DANA\_POINT\_HARBOR\_DR Cross Street: PUERTO\_PL Location: SE

ADA ID: RPRK220208144328 Ramp Type: Type 4 - Parallel Initial Pass/Fail: Fail Overall Compliance: No Severity Score: 16

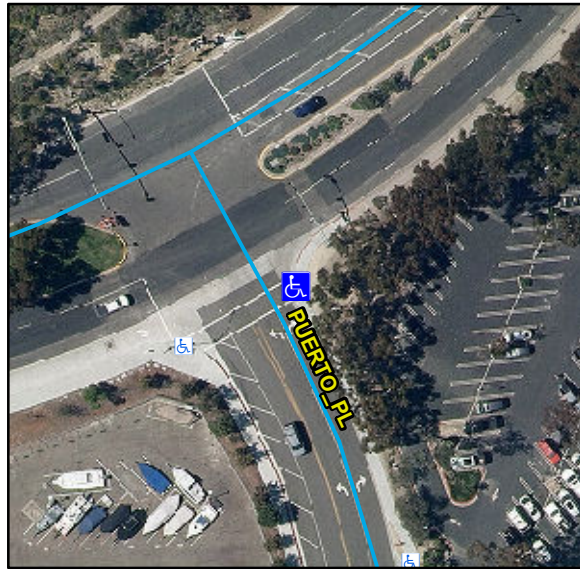
| Compliance | Description | Data | Compliance | Description | Data |
|---|---|---|---|---|---|
| No | Ramp Run Slope LT (%) | 8.5 | Yes | Ramp Run Slope RT (%) | 6.8 |
| No | Ramp Cross Slope LT (%) | 2.9 | Yes | Ramp Cross Slope RT (%) | 0.1 |

**Remove & Replace Curb Ramp With Two New Directional Ramps or Equivalent.**

**R304.3.2, R304.5.3, STD 1115**
