# Access Compliance Report Public Rights-of-Way (Curb Ramps)

Main Street: PUERTO\_PL Cross Street: PUERTO\_PL Location: NW

ADA ID: RPRK220208151419 Ramp Type: Type 4 - Parallel Initial Pass/Fail: Fail Overall Compliance: No Severity Score: 2

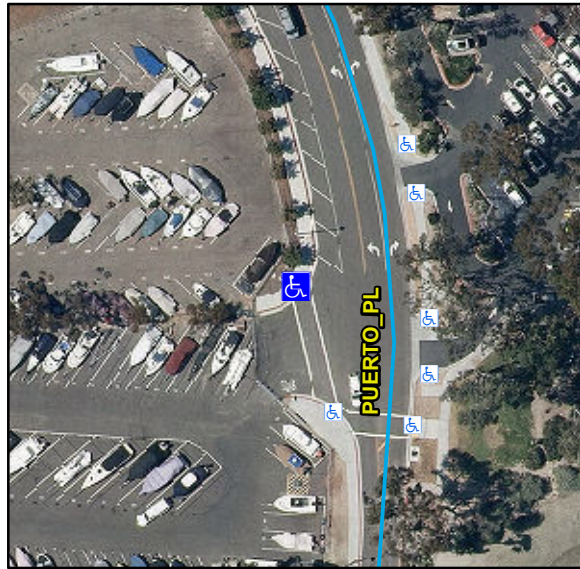
| Compliance | Description | Data | Compliance | Description | Data |
|---|---|---|---|---|---|
| No | Ramp Cross Slope LT (%) | 4 | Yes | Ramp Cross Slope RT (%) | 0.4 |

**Remove & Replace Curb Ramp With Two New Directional Ramps or Equivalent.**

**R304.5.3, STD 1115**
