# Access Compliance Report Public Rights-of-Way (Curb Ramps)

Main Street: N/A Cross Street: PUERTO\_PL Location: E

ADA ID: RPRK220208153436 Ramp Type: Type 6 - Directional 1 Initial Pass/Fail: Pass Overall Compliance: No Severity Score: 5

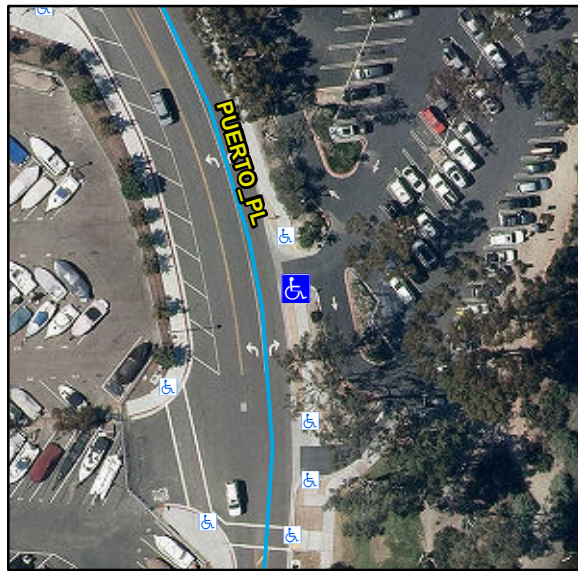
| Compliance | Description | Data | Compliance | Description | Data |
|---|---|---|---|---|---|
| No | Grade Break | No | N/A | Flare Type RT | |
| No | Landing Run Slope (%) | 2.1 | | DWS Offset Type | Single |
| No | Gutter Run Slope (%) | 6 | | Road Cross Slope (%) | N/A |
| No | Gutter Cross Slope (%) | 2.2 | | Parallel Ramp Side | N/A |

Remove & Replace Entire Ramp. Remove & Replace Gutter.
