# Access Compliance Report Public Rights-of-Way (Curb Ramps)

| Main Street: N/A | | Cross Street: PUERTO_PL | | Location: | E |
| ADA ID: RPRK220208153945 | Ramp Type: Type 6 - Directional 1 | Initial Pass/Fail: Pass | Overall Compliance: No | Severity Score: | 2 |

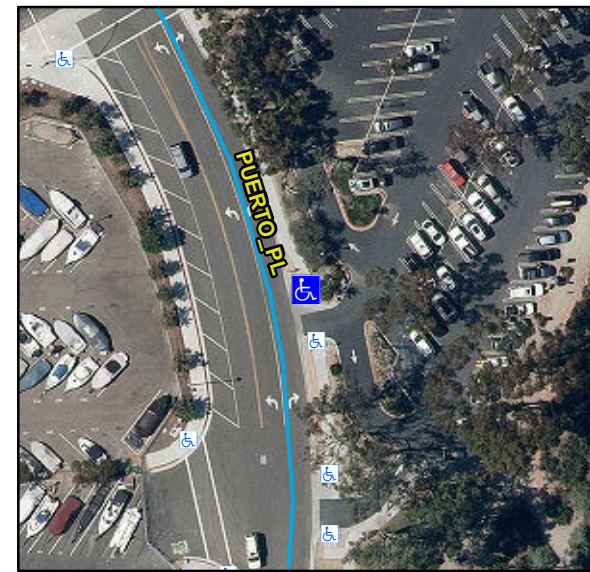
Gutter Ponding Observed.

| Compliance | Description | Data | Compliance | Description | Data |
|---|---|---|---|---|---|
| No | Gutter Ponding | Yes | Yes | Curb Slope | 0.2 |
