# Access Compliance Report Public Rights-of-Way (Curb Ramps)

Main Street: CASITAS\_PL Cross Street: DANA\_POINT\_HARBOR\_DR Location: SW

ADA ID: RPRK220208171207 Ramp Type: Type 1 - Perpendicular Diagonal Initial Pass/Fail: Pass Overall Compliance: No Severity Score: 2

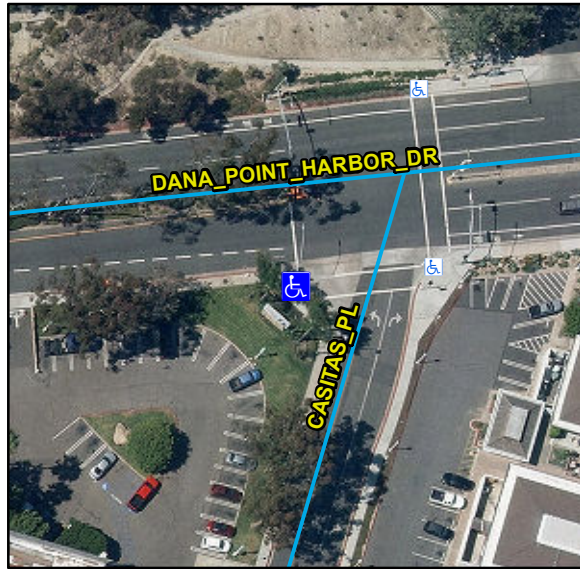
Remove & Replace Landing. Gutter Ponding Observed.

| Compliance | Description | Data | Compliance | Description | Data |
|---|---|---|---|---|---|
| N/A | Landing Movement Obstructed? | Yes | Yes | DWS Contrast | Yes |
| No | Gutter Ponding | Yes | Yes | Curb Slope | 0.9 |

### Possible Solutions:
