# Access Compliance Report Public Rights-of-Way (Curb Ramps)

Main Street: ISLAND\_WAY Cross Street: DANA\_DR Location: E

ADA ID: RPRK220208173428 Ramp Type: Type 1 - Perpendicular Diagonal Initial Pass/Fail: Fail Overall Compliance: No Severity Score: 19

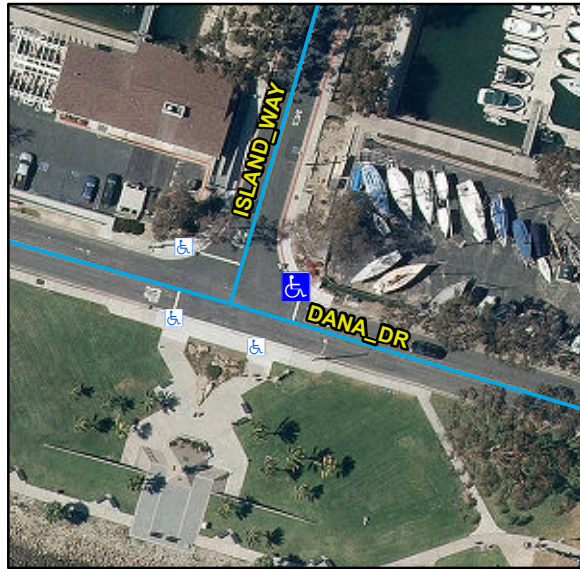
| Compliance | Description | Data | Compliance | Description | Data |
|---|---|---|---|---|---|
| No | Ramp Width (in) | 47 | | | N/A |
| No | Ramp Run Slope (%) | 10.3 | N/A | Flare Slope LT (%) | N/A |

Remove & Replace Curb Ramp With Two New Directional Ramps or Equivalent.

R204.3, R304.5.1, R304.2.2, STD 1115
