Main Street: DANA\_DR Cross Street: ISLAND\_WAY Location: W

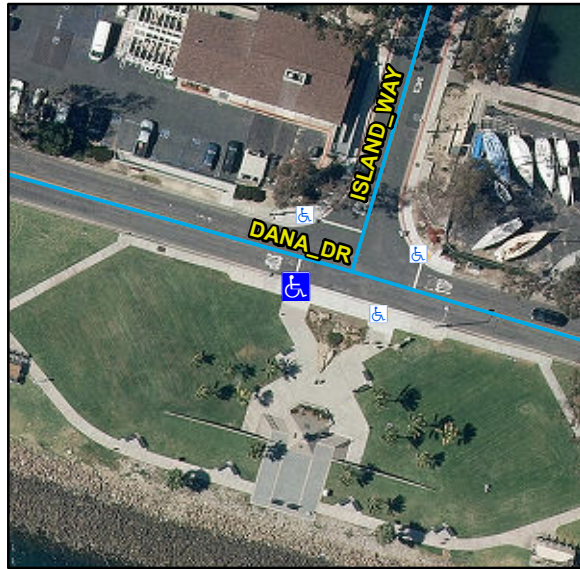
| Compliance | Description | Data | Compliance | Description | Data |
|---|---|---|---|---|---|
| Yes | Landing Run Slope (%) | 0.9 | N/A | Flare Traversable RT | Yes |
| | Crossing 1 Cross Slope (%) | 3.5 | | Crossing 2 Cross Slope (%) | N/A |
| Yes | Gutter Run Slope (%) | 0.5 | | Road Cross Slope (%) | N/A |

### Possible Solutions:
