# Access Compliance Report Public Rights-of-Way (Curb Ramps)

Main Street: DANA\_DR Cross Street: ISLAND\_WAY Location: S

ADA ID: RPRK220208174545 Ramp Type: Type 1 - Perpendicular Initial Pass/Fail: Pass Overall Compliance: No Severity Score: 0

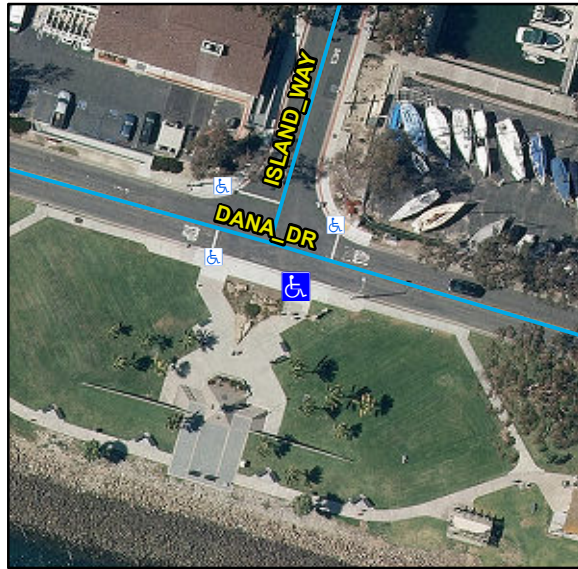
Gutter Ponding Observed.

| Compliance | Description | Data | Compliance | Description | Data |
|---|---|---|---|---|---|
| No | Gutter Ponding | Yes | Yes | Curb Slope | 1.6 |

Possible Solutions:

R302.7, STD 1115

Total Cost: \$ 252
