# Access Compliance Report Public Rights-of-Way (Curb Ramps)

Main Street: N/A Cross Street: DANA\_POINT\_HARBOR\_DR Location: S

ADA ID: RPRK220208175138 Ramp Type: Type 1 - Perpendicular Initial Pass/Fail: Fail Overall Compliance: No Severity Score: 32

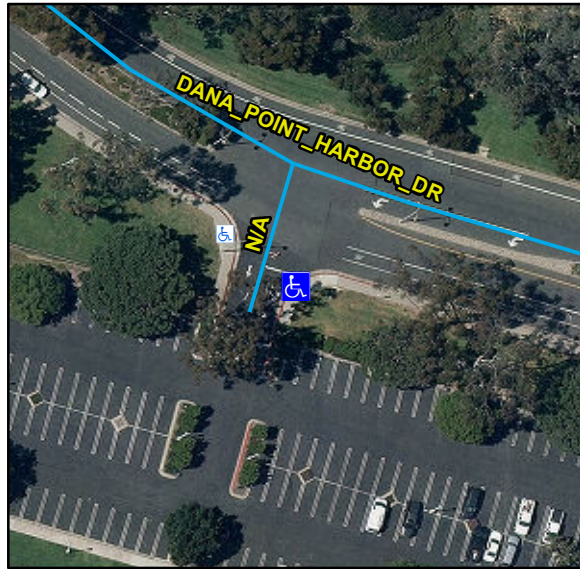
| Compliance | Description | Data | Compliance | Description | Data |
|---|---|---|---|---|---|
| No | Ramp Run Slope (%) | 12.3 | N/A | Flare Slope LT (%) | N/A |

Remove & Replace Entire Ramp.

R204.3, R304.2.2, STD 1115

Total Cost: \$ 3080
