# Access Compliance Report Public Rights-of-Way (Curb Ramps)

| Main Street: N/A | | Cross Street: DANA_POINT_HARBOR_DR | | Location: | W |
| ADA ID: RPRK220208175508 | Ramp Type:Type 1 - Perpendicular | Initial Pass/Fail: Fail | Overall Compliance: No | Severity Score: | 15 |

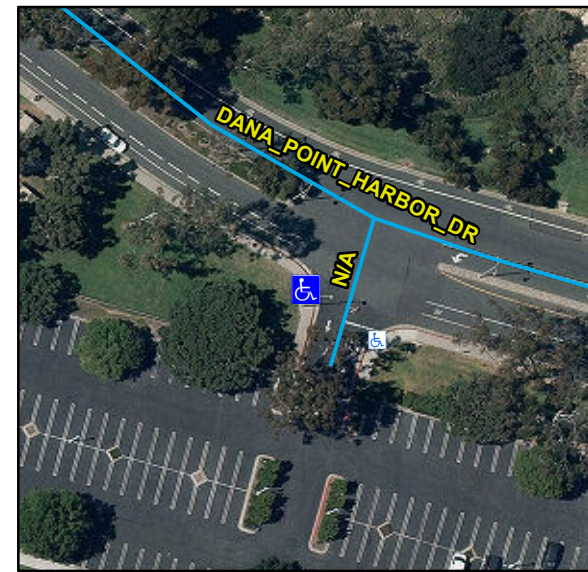
| Compliance | Description | Data | Compliance | Description | Data |
|---|---|---|---|---|---|
| No | Ramp Run Slope (%) | 11.1 | N/A | Flare Slope LT (%) | N/A |

Possible Solutions:

Remove & Replace Entire Ramp.

R204.3, R304.2.2, STD 1115

Total Cost: \$ 3080
