# Access Compliance Report Public Rights-of-Way (Curb Ramps)

Main Street: COVE\_RD Cross Street: DANA\_POINT\_HARBOR\_DR Location: NW

ADA ID: RPRK220208180604 Ramp Type: Type 1 - Perpendicular Initial Pass/Fail: Pass Overall Compliance: No Severity Score: 2

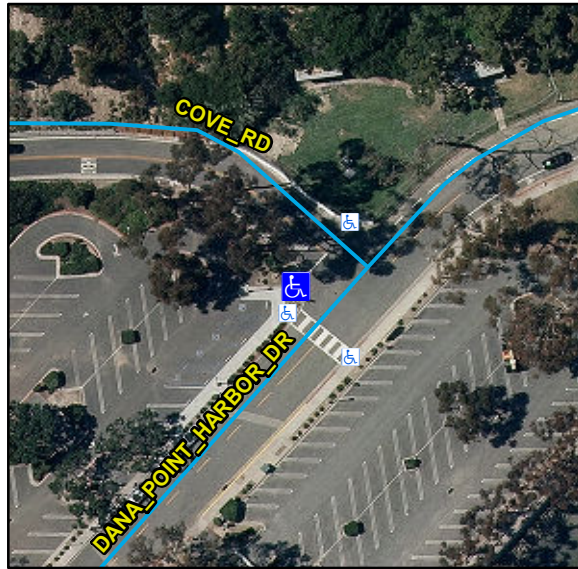
Gutter Ponding Observed.

| Compliance | Description | Data | Compliance | Description | Data |
|---|---|---|---|---|---|
| No | Gutter Ponding | Yes | Yes | Curb Slope | 0.5 |

R302.7, STD 1115
