# Access Compliance Report Public Rights-of-Way (Curb Ramps)

| Main Street: DANA_POINT_HARBOR_DR | | Cross Street: COVE_RD | | Location: | S |
| ADA ID: RPRK220208181052 | Ramp Type: Type 4 - Parallel | Initial Pass/Fail: Fail | Overall Compliance: No | Severity Score: | 45 |

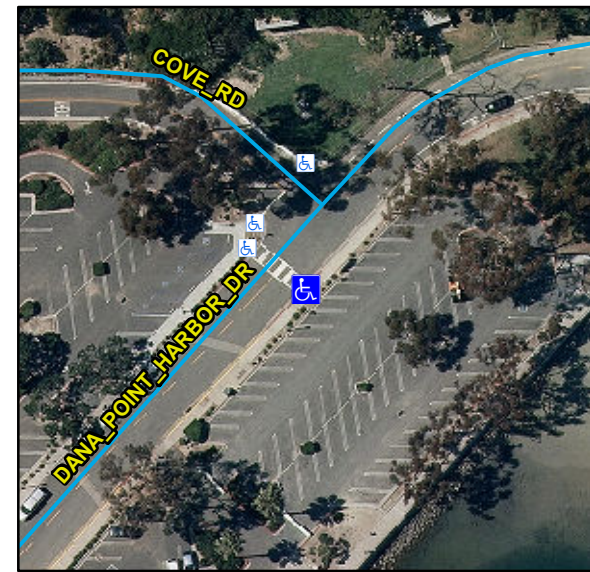
| Compliance | Description | Data | Compliance | Description | Data |
|---|---|---|---|---|---|
| Yes | Ramp Run Slope LT (%) | 6.9 | No | Ramp Run Slope RT (%) | 14.6 |
| Yes | Ramp Cross Slope LT (%) | 2 | No | Ramp Cross Slope RT (%) | 5.7 |

Possible Solutions:

Remove & Replace Entire Ramp.

R304.3.2, R304.5.3, STD 1115

Total Cost: \$ 2000
