# Access Compliance Report Public Rights-of-Way (Curb Ramps)

Main Street: WEATHERBY\_RD Cross Street: HEDWIG\_RD Location: SW

ADA ID: RPRK220217145302 Ramp Type: Type 1 - Perpendicular Diagonal Initial Pass/Fail: Pass Overall Compliance: No Severity Score: 6

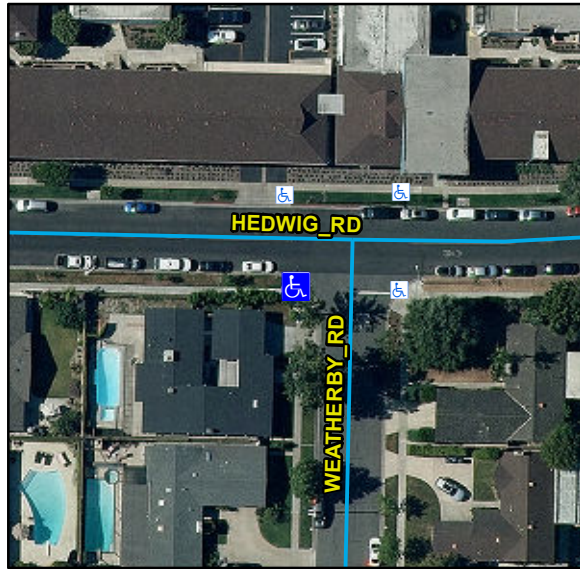
| Compliance | Description | Data | Compliance | Description | Data |
|---|---|---|---|---|---|
| No | Landing Run Slope (%) | 3.2 | N/A | Flare Traversable RT | No |
| No | Landing Cross Slope (%) | 2.5 | Yes | DWS Provided | Yes |
| No | Gutter Run Slope (%) | 7.5 | | Road Cross Slope (%) | 3.5 |
| No | Gutter Cross Slope (%) | 5.7 | | | |

Remove & Replace Landing. Remove & Replace Gutter.
