# Access Compliance Report Public Rights-of-Way (Curb Ramps)

Main Street: HEDWIG\_RD Cross Street: WEATHERBY\_RD Location: SE

ADA ID: RPRK220217150125 Ramp Type: Type 1 - Perpendicular Diagonal Initial Pass/Fail: Pass Overall Compliance: No Severity Score: 9

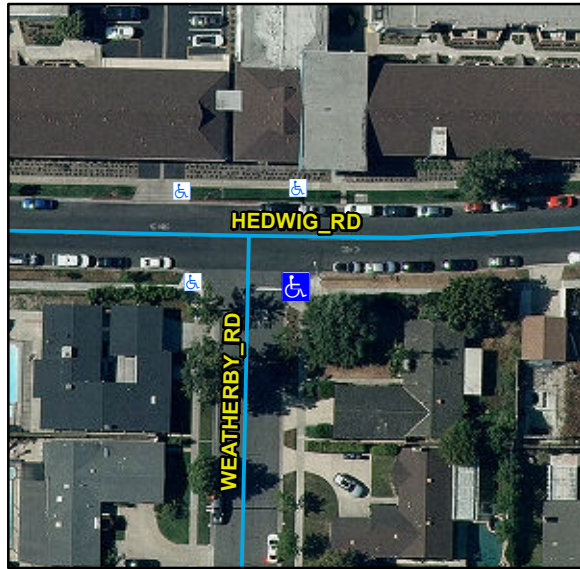
| Compliance | Description | Data | Compliance | Description | Data |
|---|---|---|---|---|---|
| N/A | Landing Movement Obstructed? | Yes | Yes | DWS Contrast | Yes |
| | Landing Movement Type | Bushes | Yes | DWS Length (in) | 36 |
| No | Gutter Run Slope (%) | 5.3 | | Road Cross Slope (%) | 4.5 |

Remove & Replace Landing. Remove & Replace Gutter.

R304.2.1, R304.5.4, STD 1115
