# Access Compliance Report Public Rights-of-Way (Curb Ramps)

Main Street: HEDWIG\_RD Cross Street: DAVENPORT\_RD Location: W

ADA ID: RPRK220217151352 Ramp Type: Type 1 - Perpendicular Diagonal Initial Pass/Fail: Pass Overall Compliance: No Severity Score: 19

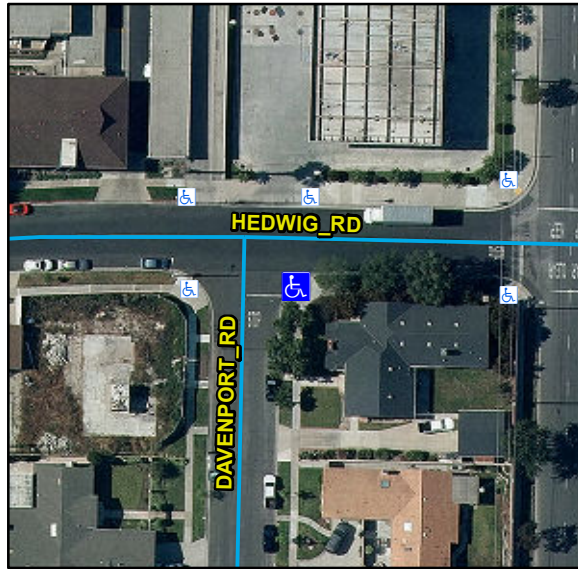
| Compliance | Description | Data | Compliance | Description | Data |
|---|---|---|---|---|---|
| Yes | Landing Cross Slope (%) | 1.5 | No | DWS Provided | No |
| No | Gutter Run Slope (%) | 9.2 | | Road Cross Slope (%) | 3.3 |

Remove & Replace Curb Ramp With Two New Directional Ramps or Equivalent. Remove & Replace Gutter.
