# Access Compliance Report Public Rights-of-Way (Curb Ramps)

Main Street: LOS\_ALAMITOS\_BLV D Cross Street: HEDWIG\_RD Location: SW

ADA ID: RPRK220217152041 Ramp Type: Type 4 - Parallel Initial Pass/Fail: Fail Overall Compliance: No Severity Score: 2

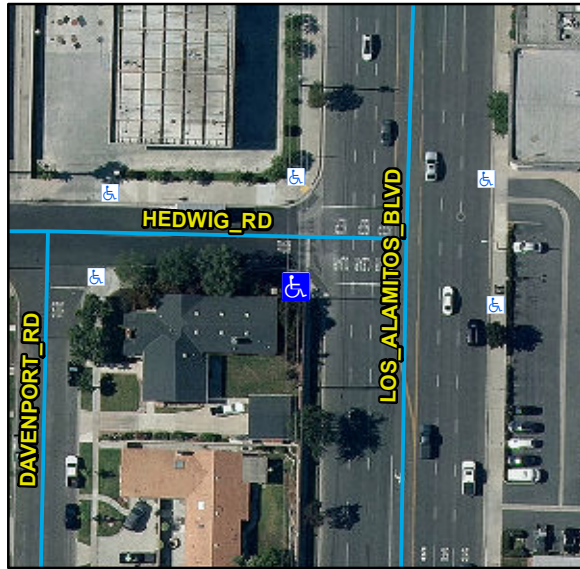
| Compliance | Description | Data | Compliance | Description | Data |
|---|---|---|---|---|---|
| No | Ramp Cross Slope LT (%) | 3.4 | Yes | Ramp Cross Slope RT (%) | 1.9 |

**Remove & Replace Curb Ramp With Two New Directional Ramps or Equivalent.**

**R304.5.3, STD 1115**
