# Access Compliance Report Public Rights-of-Way (Curb Ramps)

Main Street: HEDWIG\_RD Cross Street: LOS\_ALAMITOS\_BLVD Location: NW

ADA ID: RPRK220217152614 Ramp Type: Type 1 - Perpendicular Diagonal Initial Pass/Fail: Fail Overall Compliance: No Severity Score: 16

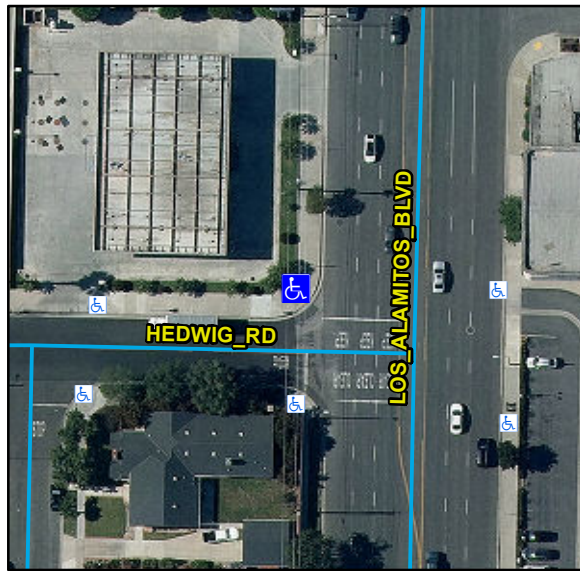
| Compliance | Description | Data | Compliance | Description | Data |
|---|---|---|---|---|---|
| No | Ramp Run Slope (%) | 8.6 | N/A | Flare Slope LT (%) | N/A |
| No | Ramp Cross Slope (%) | 3.7 | N/A | Flare Traversable LT | N/A |

Remove & Replace Curb Ramp With Two New Directional Ramps or Equivalent.

R304.2.2, R304.5.3, STD 1115
