# Access Compliance Report Public Rights-of-Way (Curb Ramps)

Main Street: HEDWIG\_RD Cross Street: WALLINGSFORD\_RD Location: SE

ADA ID: RPRK220217153905 Ramp Type: Type 4 - Parallel Initial Pass/Fail: Fail Overall Compliance: No Severity Score: 15

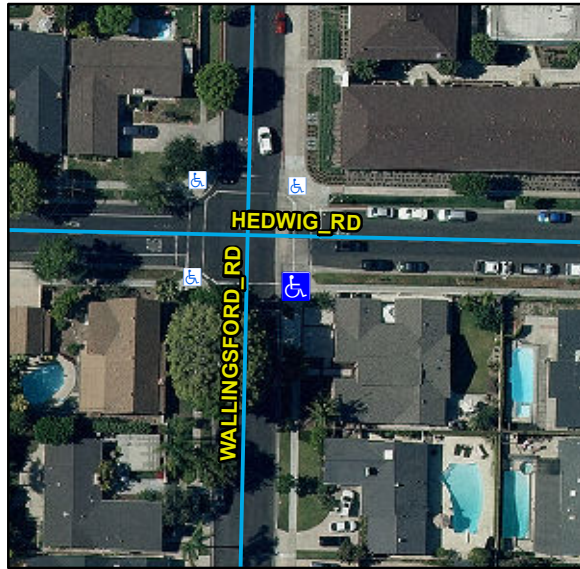
| Compliance | Description | Data | Compliance | Description | Data |
|---|---|---|---|---|---|
| No | Ramp Cross Slope LT (%) | 7 | No | Ramp Cross Slope RT (%) | 3.1 |
| No | Gutter Lip Height (in) | 2.1 | | Road Run Slope (%) | 2.1 |

**Remove & Replace Curb Ramp With Two New Directional Ramps or Equivalent. Grind Gutter Lip.**

**R204.3, R304.5.3, R302.7.2, STD 1115**
