# Access Compliance Report Public Rights-of-Way (Curb Ramps)

Main Street: WALLINGSFORD\_RD Cross Street: HEDWIG\_RD Location: SW

ADA ID: RPRK220217154402 Ramp Type: Type 1 - Perpendicular Diagonal Initial Pass/Fail: Fail Overall Compliance: No Severity Score: 15

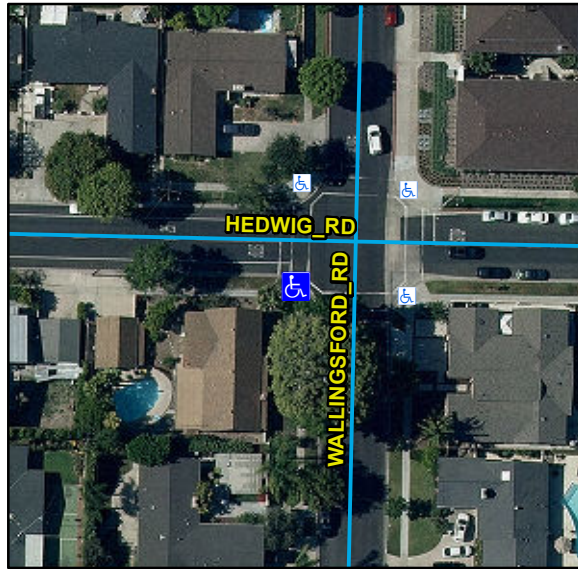
| Compliance | Description | Data | Compliance | Description | Data |
|---|---|---|---|---|---|
| No | Ramp Run Slope (%) | 8.5 | N/A | Flare Slope LT (%) | N/A |

**Remove & Replace Curb Ramp With Two New Directional Ramps or Equivalent.**
