# Access Compliance Report Public Rights-of-Way (Curb Ramps)

Main Street: HEDWIG\_RD Cross Street: WALLINGSFORD\_RD Location: NW

ADA ID: RPRK220217154817 Ramp Type: Type 1 - Perpendicular Diagonal Initial Pass/Fail: Pass Overall Compliance: No Severity Score: 20

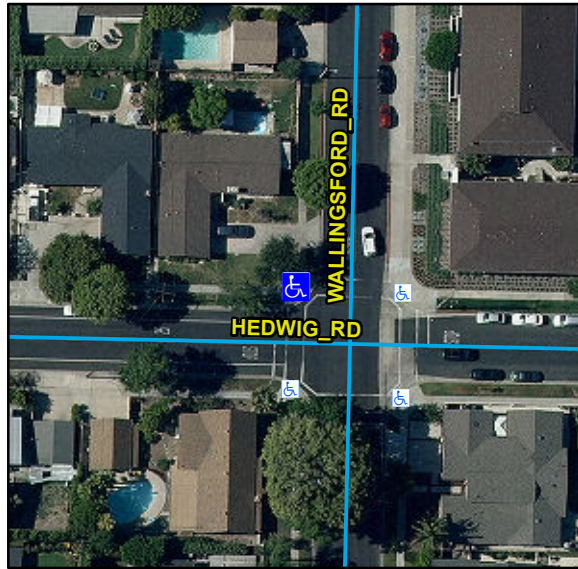
| Compliance | Description | Data | Compliance | Description | Data |
|---|---|---|---|---|---|
| No | Landing Run Slope (%) | 2.8 | N/A | Flare Traversable RT | No |
| Yes | Landing Cross Slope (%) | 1.9 | No | DWS Provided | No |
| No | Gutter Run Slope (%) | 5.3 | | Road Cross Slope (%) | 6.4 |

Remove & Replace Curb Ramp With Two New Directional Ramps or Equivalent. Remove & Replace Gutter.
