# Access Compliance Report Public Rights-of-Way (Curb Ramps)

Main Street: WALLINGSFORD\_RD Cross Street: HEDWIG\_RD Location: NE

ADA ID: RPRK220217155244 Ramp Type: Type 1 - Perpendicular Diagonal Initial Pass/Fail: Pass Overall Compliance: No Severity Score: 22

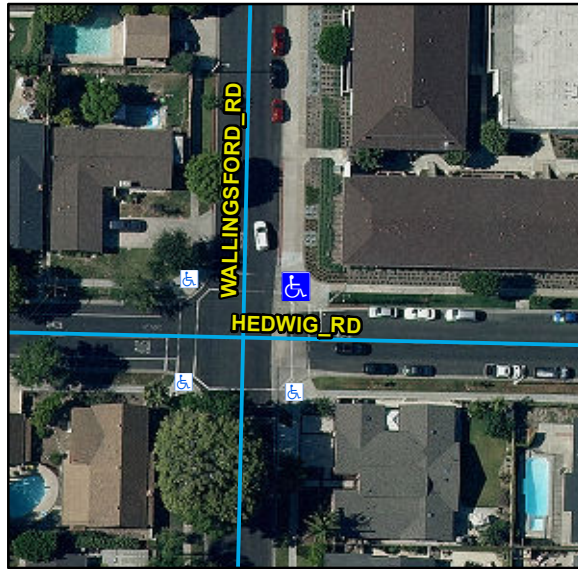
| Compliance | Description | Data | Compliance | Description | Data |
|---|---|---|---|---|---|
| No | Landing Width (in) | N/A | N/A | Flare Slope RT (%) | 8.3 |
| No | Landing Run Slope (%) | N/A | N/A | Flare Traversable RT | No |
| No | Landing Cross Slope (%) | N/A | No | DWS Provided | No |

Remove & Replace Curb Ramp With Two New Directional Ramps or Equivalent.
