# Access Compliance Report Public Rights-of-Way (Curb Ramps)

Main Street: HEDWIG\_RD Cross Street: DONNIS\_RD Location: S

ADA ID: RPRK220217163840 Ramp Type: Type 1 - Perpendicular Initial Pass/Fail: Pass Overall Compliance: No Severity Score: 5

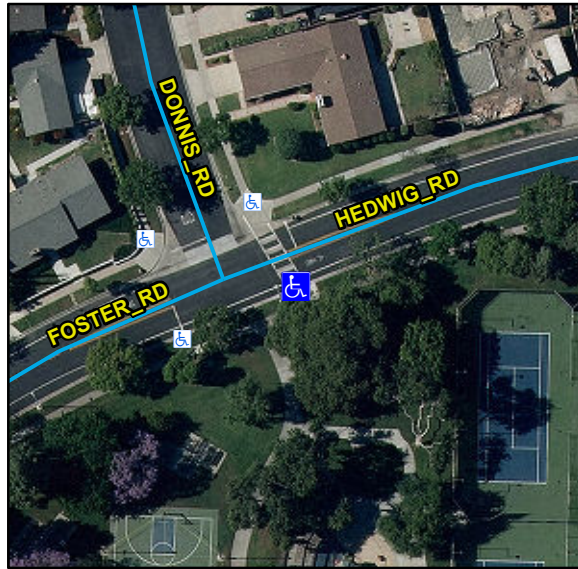
| Compliance | Description | Data | Compliance | Description | Data |
|---|---|---|---|---|---|
| N/A | Landing Movement Obstructed? | Yes | Yes | DWS Contrast | Yes |
| | Landing Movement Type | Curb | Yes | DWS Length (in) | 36 |
| No | Gutter Run Slope (%) | 10.4 | | Road Cross Slope (%) | N/A |

Remove & Replace Landing. Remove & Replace Gutter.

R304.2.1, R304.5.4, STD 1115

Total Cost: \$ 783
